Manhole Inspection Summary

Manhole # S09CC2012MH

Location Address: **5825 WESTERN RUN DRIVE**

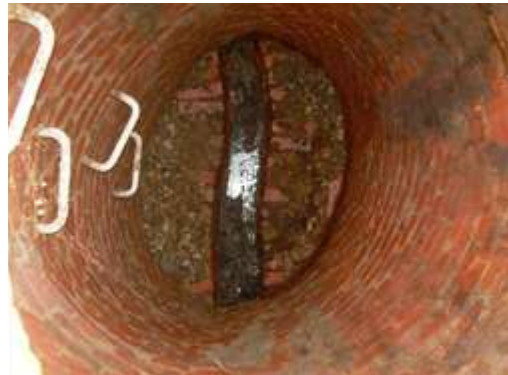
Top View

Evidence of surcharge - Bench debris.
Channel debris.

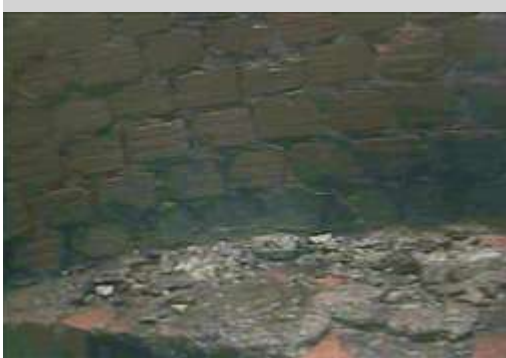
Defect

Condition: ☐ Sound ☐ Cracked ☐ Root Intrusion ☐ Loose Brick ☒ **Deteriorated**

Infiltration: ☐ None ☐ Joint ☐ Cracks ☒ **Mortar** ☐ Roots ☐ Wall

Barrel deterioration and infiltration.

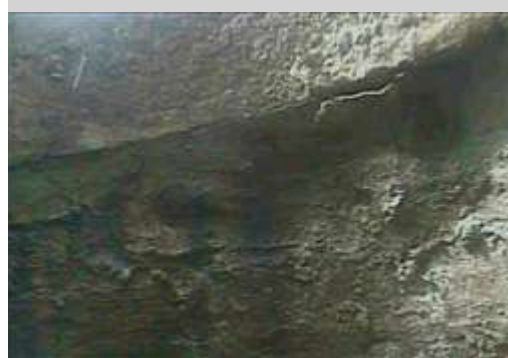
Defect

☒ **Leaks**

Infiltration: ☐ None ☒ **Joint** ☐ Cracks ☒ **Mortar** ☐ Roots ☐ Wall

Frame leaks. Adjustment infiltration.

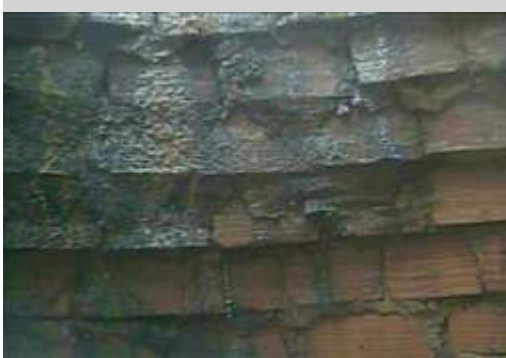
Defect

Infiltration: ☐ None ☐ Joint ☐ Cracks ☒ **Mortar** ☐ Roots ☐ Wall

Adjustment and Corbel infiltration.

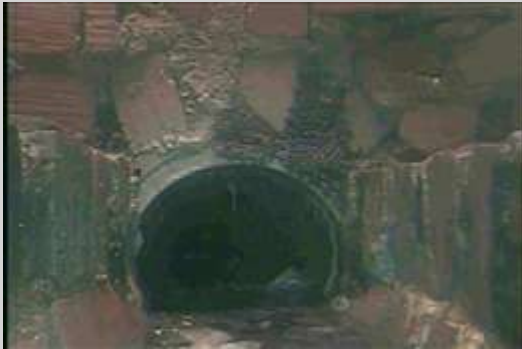
8 in. Circular Gravity Sewer Pipe Out @ 12 O'Clock

Channel deterioration.

Infiltration: **Evidence** Pipe Seal Cond: **Unknown**

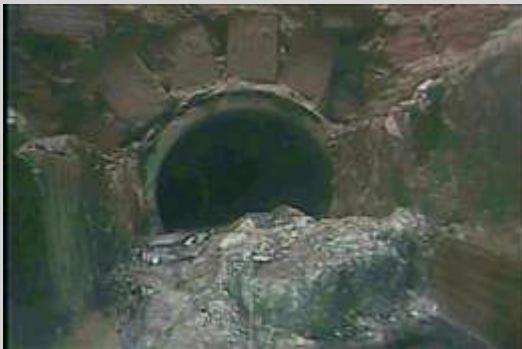
8 in. Circular Gravity Sewer Pipe In @ 7 O'Clock

Deposits: ☐ None ☐ Mud ☐ Sludge ☒ **Debris** ☐ Grease

Silt Depth: **3** (in.) Deposits Extent: **Medium**

Infiltration: **Evidence** Pipe Seal Cond: **Unknown**
